**Flood Control Project Maintenance  
Levee Inspections**

## Maintenance Issue Types Only, Levee Inspection Report By Mile - Spring 2017

### Reclamation District No. 1001 Nicolaus

Waterway	Bank	Unit Miles	Inspection Start/End	Inspector
Unit No. 01 Yankee Slough	Right	4.12	03/28/2017 03/28/2017	Sterling York

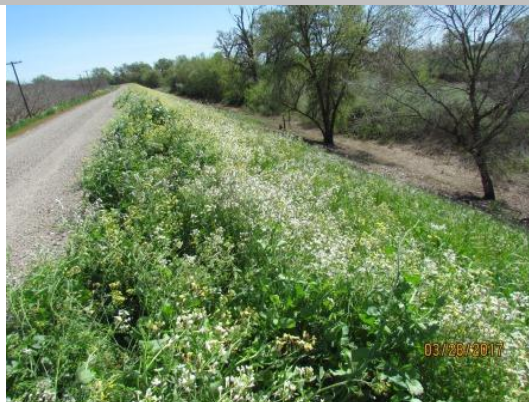
Photo 1 of 1 : SP\_2017\_RD1001\_36\_17\_20170403\_00022.jpg

LM Start	0.14	Rating **	U	Issue No.	17
LM End	3.83	Issue Type +	Ma	Location *	WS
Category	Earthen Levee			GPS Latitude/Longitude	
				Start	End
Item	Vegetation			38.978880 °	38.966766 °
				-121.471988 °	-121.533397 °
DWR ID	DWR_RD1001_01_s_2017_17				
Comment Code					
V1 : Control annual grass and weeds on the levee slopes and easements.					
Inspector Comment					
Maintain annual vegetation. Spring 2017.

View looking upstream of annual grasses, Spring 2017.

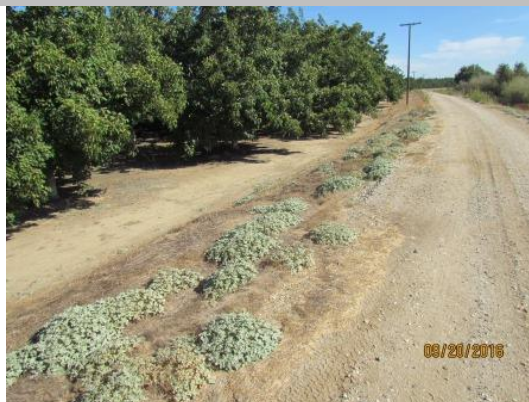
Photo 1 of 1 : SP\_2017\_RD1001\_36\_25\_20170316\_00019.jpg

LM Start	1.40	Rating **	M	Issue No.	25
LM End	1.40	Issue Type +	Ma	Location *	LS
Category	Earthen Levee			GPS Latitude/Longitude	
				Start	End
Item	Slope Stability			38.971589 °	38.971589 °
				-121.492049 °	-121.492049 °
DWR ID	DWR_RD1001_01_f_2016_25				
Comment Code					
S3 : Repair the levee slope damaged by vehicle traffic and prevent access where possible.					
Inspector Comment					
Slope is stable and shows no eroision, Spring 2017.

View of tier ruts on the landside levee slope looking upstream. Fall 2016.

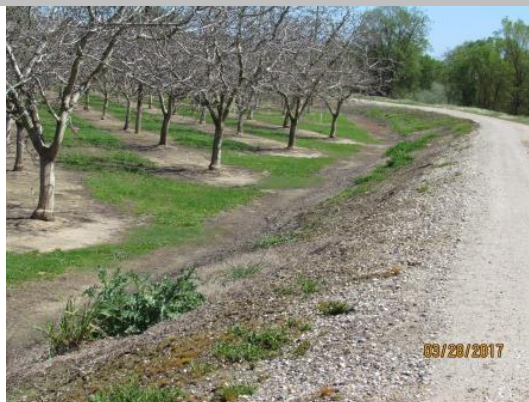
Photo 1 of 1 : SP\_2017\_RD1001\_36\_21\_20170403\_00026.jpg

LM Start	1.52	Rating **	A	Issue No.	21
LM End	1.86	Issue Type +	Ma	Location *	LS
Category	Earthen Levee			GPS Latitude/Longitude	
				Start	End
Item	Vegetation			38.970688 °	38.971170 °
				-121.494025 °	-121.500088 °
DWR ID	DWR_RD1001_01_s_2017_21				
Comment Code					
V1 : Control annual grass and weeds on the levee slopes and easements.					
Inspector Comment					
Well maintained annual vegetation. Spring 2017.

View of well maintained annual vegetation looking upstream, landside. Spring 2017.

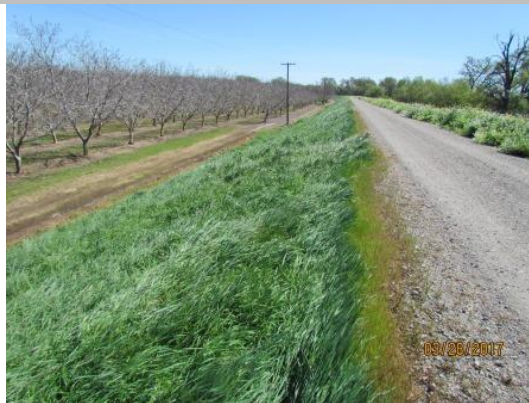
Photo 1 of 1 : SP\_2017\_RD1001\_36\_13\_20170403\_00021.jpg

View looking upstream of annual grasses, Spring 2017.

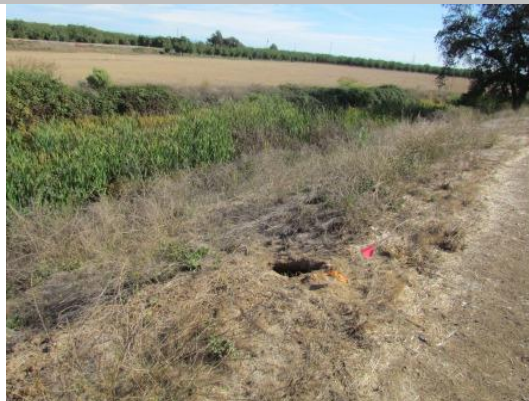
Photo 1 of 3 : SP\_2017\_RD1001\_35\_4\_20170316\_00001.jpg

LM Start	0.27	Rating **	A/W	Issue No.	4
LM End	0.27	Issue Type +	Ma	Location *	WS
Category	Earthen Levee			GPS Latitude/Longitude	
				Start	End
Item	Animal Control			38.974323 °	38.974323 °
				-121.476442 °	-121.476442 °
DWR ID	DWR_RD1001_02_f_2014_4				
Comment Code					
A3 : No rodents visible, but rodent burrows visible; need to backfill and compact or grout burrows.					
Inspector Comment					
There is no animal activity at this location, the existing hole near the crown has been backfill & repaired by the District, Spring 2017.

This photo was taken from the levee crown facing east looking down the waterward slope at an animal burrow. Fall 2014.

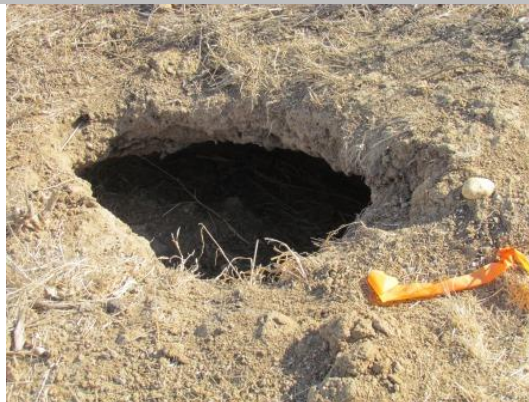
Photo 2 of 3 : SP\_2017\_RD1001\_35\_4\_20170316\_00002.jpg

Another picture of the animal burrow. Fall 2014.

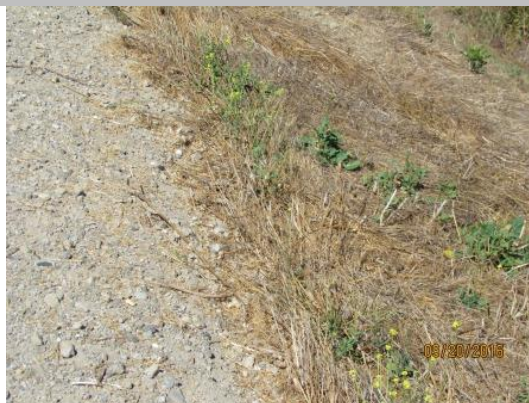
Photo 3 of 3 : SP\_2017\_RD1001\_35\_4\_20170316\_00003.jpg

LM Start	0.27	Rating **	A/W	Issue No.	4 (cont)	
LM End	0.27	Issue Type +	Ma	Location *	WS	
Category	Earthen Levee			GPS Latitude/Longitude		
				Start	End	
Item	Animal Control			38.974323 °	38.974323 °	
				-121.476442 °	-121.476442 °	
DWR ID	DWR_RD1001_02_f_2014_4					
Comment Code						
A3 : No rodents visible, but rodent burrows visible; need to backfill and compact or grout burrows.						
Inspector Comment						
There is no animal activity at this location, the existing hole near the crown has been backfill & repaired by the District, Spring 2017.

Although hard to see with the grass, there is still an animal hole on waterward levee slope near the crown at this location. Hole was approximately 1' in diameter and 8" deep that needs to be repaired. There is no animal activity at this location. Fall 2016.

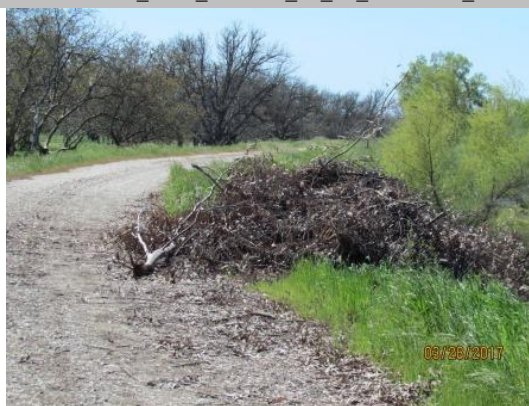
Photo 1 of 1 : SP\_2017\_RD1001\_35\_14\_20170403\_00029.jpg

LM Start	1.11	Rating **	M	Issue No.	14
LM End	1.11	Issue Type +	Ma	Location *	WS
Category	Earthen Levee			GPS Latitude/Longitude	
				Start	End
Item	Encroachments			38.971521 °	38.971521 °
				-121.490987 °	-121.490987 °
DWR ID	DWR_RD1001_02_s_2017_14				
Comment Code					
PR : Prunings					
Inspector Comment					
Remove prunings from levees hinge point, Spring 2017.

View looking downstream of pruning's on levee hinge point, Spring 2017.

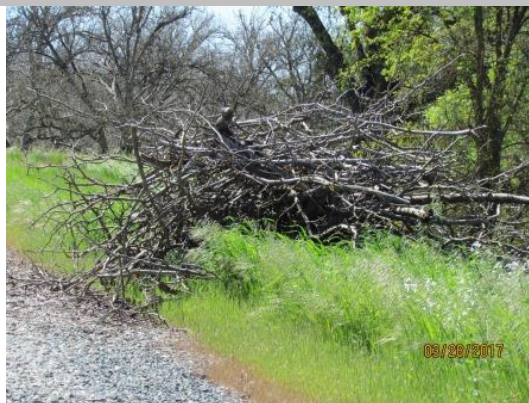
Photo 1 of 1 : SP\_2017\_RD1001\_35\_15\_20170403\_00030.jpg

View looking downstream of pruning's on levee hinge point, Spring 2017.

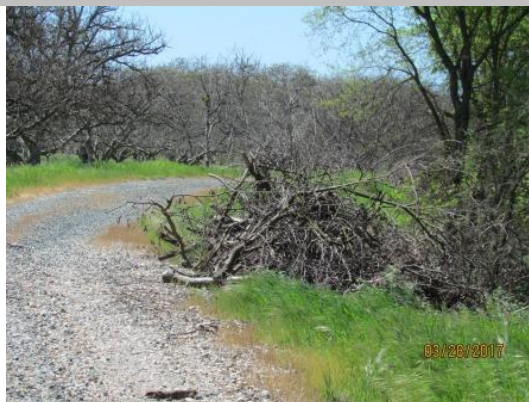
Photo 1 of 1 : SP\_2017\_RD1001\_35\_17\_20170403\_00031.jpg

View looking downstream of pruning's on levee hinge point, Spring 2017.

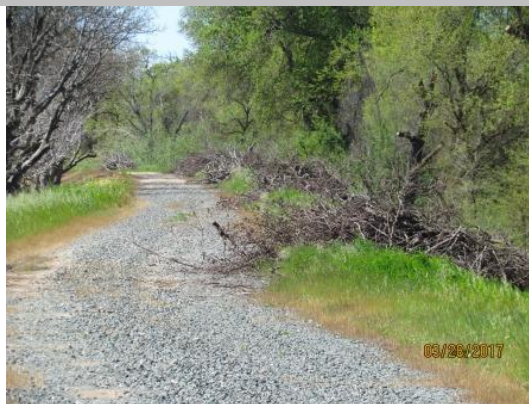
Photo 1 of 1 : SP\_2017\_RD1001\_35\_20\_20170403\_00032.jpg

View looking downstream of pruning's on length of levee hinge point, Spring 2017.

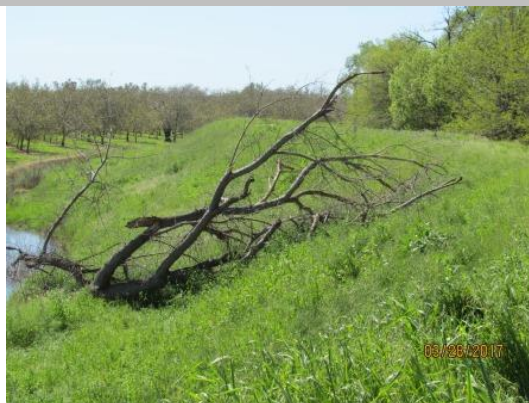
Photo 1 of 1 : SP\_2017\_RD1001\_35\_26\_20170403\_00034.jpg

View looking downstream of a tree that has fallen last rainy season and needs to be removed from slope, Spring 2017.

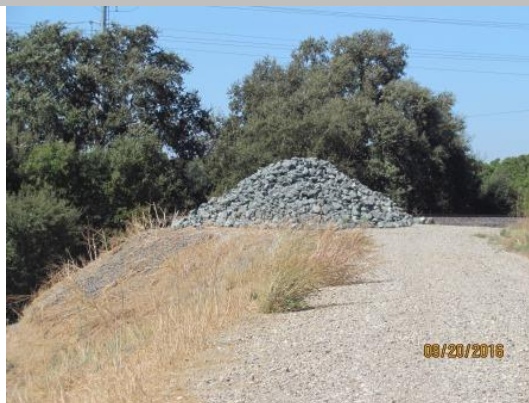
Photo 1 of 1 : SP\_2017\_RD1001\_35\_24\_20170316\_00015.jpg

View of stockpiled flood fight material. Fall 2016.

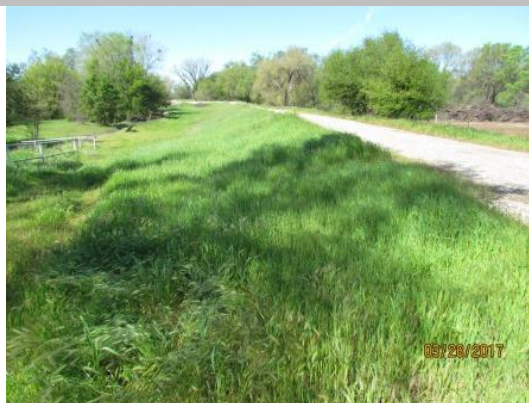
Photo 1 of 1 : SP\_2017\_RD1001\_37\_14\_20170403\_00043.jpg

View looking downstream of annual vegetation. Spring 2017.

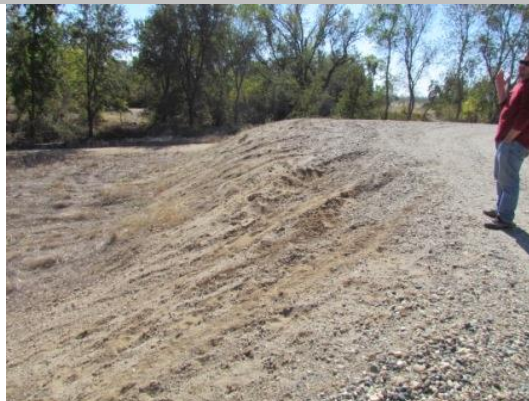
Photo 1 of 2 : SP\_2017\_RD1001\_37\_2\_20170316\_00002.jpg

LM Start	0.11	Rating **	M	Issue No.	2
LM End	0.11	Issue Type +	Ma	Location *	CR
Category	Earthen Levee			GPS Latitude/Longitude	
				Start	End
Item	Slope Stability			39.006569 °	39.006569 °
				-121.377037 °	-121.377037 °
DWR ID	DWR_RD1001_03_f_2013_2				
Comment Code					
S3 : Repair the levee slope damaged by vehicle traffic and prevent access where possible.					
Inspector Comment					
Rutting caused by vehicles driving up the landward levee slope.

This photo was taken from the crown of the levee facing west looking down the slope at rutting caused by vehicles driving up the landward levee slope. Fall 2015.

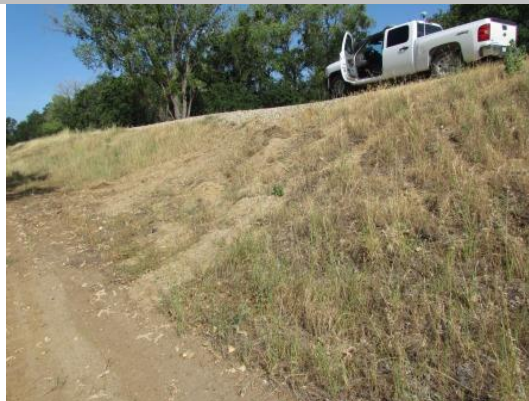
Photo 1 of 1 : SP\_2017\_RD1001\_37\_23\_20170316\_00016.jpg

LM Start	0.14	Rating **	M	Issue No.	23
LM End	0.14	Issue Type +	Ma	Location *	LS
Category	Earthen Levee			GPS Latitude/Longitude	
				Start	End
Item	Slope Stability			39.006351 °	39.006351 °
				-121.377313 °	-121.377313 °
DWR ID	DWR_RD1001_03_s_2015_23				
Comment Code					
S3 : Repair the levee slope damaged by vehicle traffic and prevent access where possible.					
Inspector Comment					
Rutting caused by vehicles driving up the landward levee slope.

View of the rutting on the landside of the levee from the toe facing downstream.

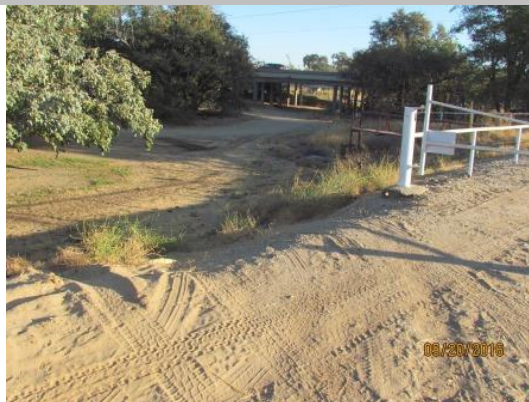
Photo 1 of 1 : SP\_2017\_RD1001\_37\_28\_20170316\_00018.jpg

LM Start	1.87	Rating **	M	Issue No.	28
LM End	1.87	Issue Type +	Ma	Location *	WS
Category	Earthen Levee			GPS Latitude/Longitude	
				Start	End
Item	Slope Stability			38.998608 °	38.998608 °
				-121.405570 °	-121.405570 °
DWR ID	DWR_RD1001_03_s_2013_28				
Comment Code					
S3 : Repair the levee slope damaged by vehicle traffic and prevent access where possible.					
Inspector Comment					
Continual damage to waterside slope caused by vehicles, suggest blocking access.

Continual damage to waterside slope caused by vehicles. Fall 2016.

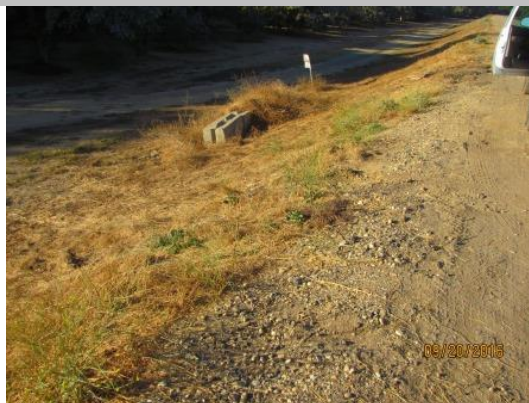
Photo 1 of 1 : SP\_2017\_RD1001\_37\_29\_20170316\_00019.jpg

LM Start	1.87	Rating **	M	Issue No.	29	
LM End	1.87	Issue Type +	Ma	Location *	LS	
Category	Earthen Levee			GPS Latitude/Longitude		
				Start		End
Item	Slope Stability			38.998608 °		38.998608 °
				-121.405570 °		-121.405570 °
DWR ID	DWR_RD1001_03_s_2013_29					
Comment Code						
S3 : Repair the levee slope damaged by vehicle traffic and prevent access where possible.						
Inspector Comment						
Continual damage caused by vehicles going around the gate, suggest blocking access.

Continual damage caused by vehicles going around the gate. Fall 2016

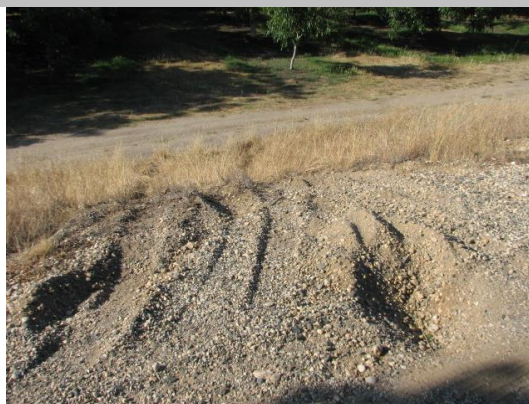
Photo 1 of 2 : SP\_2017\_RD1001\_37\_30\_20170316\_00020.jpg

LM Start	2.28	Rating **	M	Issue No.	30
LM End	2.28	Issue Type +	Ma	Location *	LS
Category	Earthen Levee			GPS Latitude/Longitude	
				Start	End
Item	Slope Stability			38.996302 °	38.996302 °
				-121.412285 °	-121.412285 °
DWR ID	DWR_RD1001_03_s_2013_30				
Comment Code					
S3 : Repair the levee slope damaged by vehicle traffic and prevent access where possible.					
Inspector Comment					
Damage to landside slope has been repaired. Continue to monitor area.

Damage caused by vehicles. Spring 2013

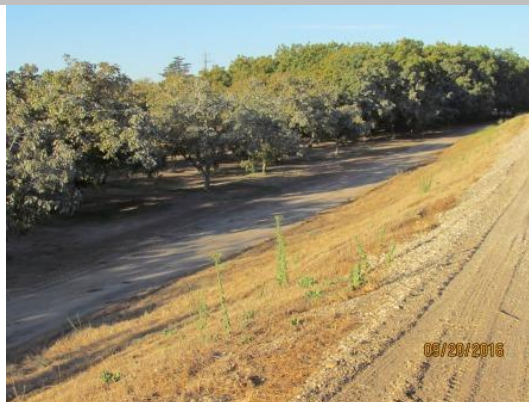
Photo 2 of 2 : SP\_2017\_RD1001\_37\_30\_20170316\_00021.jpg

Damage to landside slope has been repaired. Fall 2016.

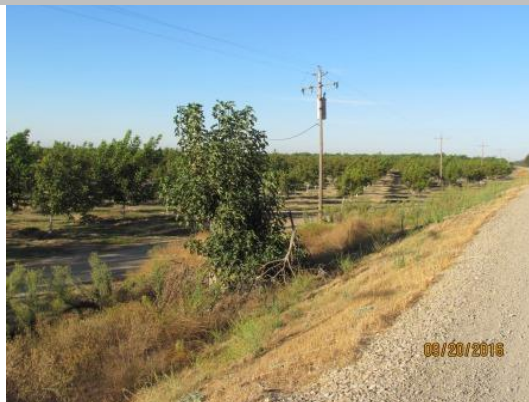
Photo 1 of 1 : SP\_2017\_RD1001\_37\_36\_20170316\_00024.jpg

View of a small starter tree on landside slope looking downstream that is less than 4" in diameter.

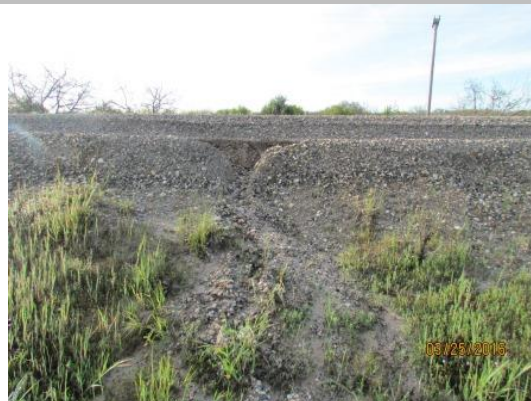
Photo 1 of 1 : SP\_2017\_RD1001\_37\_21\_20170316\_00015.jpg

LM Start	3.57	Rating **	M	Issue No.	21
LM End	3.57	Issue Type +	Ma	Location *	WS
Category	Earthen Levee			GPS Latitude/Longitude	
				Start	End
Item	Erosion / Bank Caving			38.991390 °	38.991390 °
				-121.435268 °	-121.435268 °
DWR ID	DWR_RD1001_03_s_2016_21				
Comment Code					
E2 : Schedule repair of erosion site prior to the next inspection.					
Inspector Comment

Erosion on waterside slope. Remains as of Fall 2016.

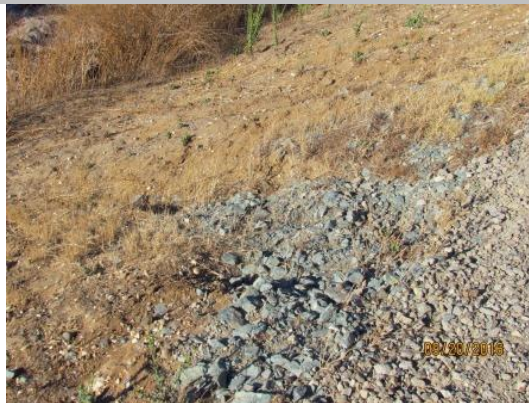
Photo 1 of 1 : SP\_2017\_RD1001\_37\_31\_20170316\_00022.jpg

LM Start	4.48	Rating **	M	Issue No.	31
LM End	4.48	Issue Type +	Ma	Location *	LS
Category	Earthen Levee			GPS Latitude/Longitude	
				Start	End
Item	Erosion / Bank Caving			38.991851 °	38.991851 °
				-121.452116 °	-121.452116 °
DWR ID	DWR_RD1001_03_f_2016_31				
Comment Code					
E2 : Schedule repair of erosion site prior to the next inspection.					
Inspector Comment

View of erosion in the landside levee slope looking downstream. Fall 2016.

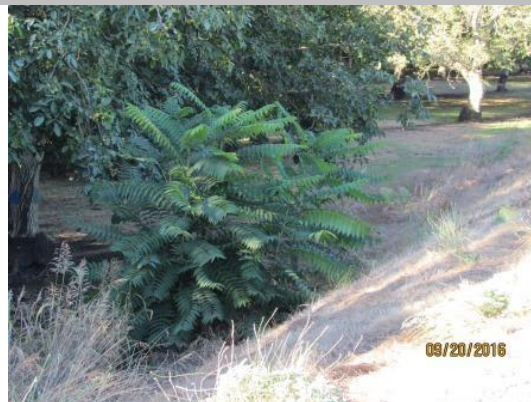
Photo 1 of 2 : SP\_2017\_RD1001\_37\_32\_20170316\_00023.jpg

View of starter tree with diameter less than 4". Fall 2016.

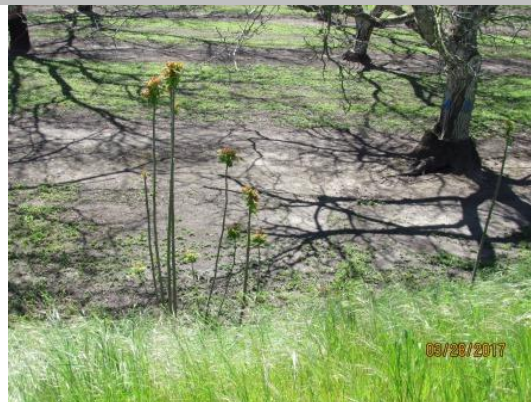
Photo 2 of 2 : SP\_2017\_RD1001\_37\_32\_20170403\_00052.jpg

View of where starter tree was removed but new starters have sprouted up, Spring 2017.

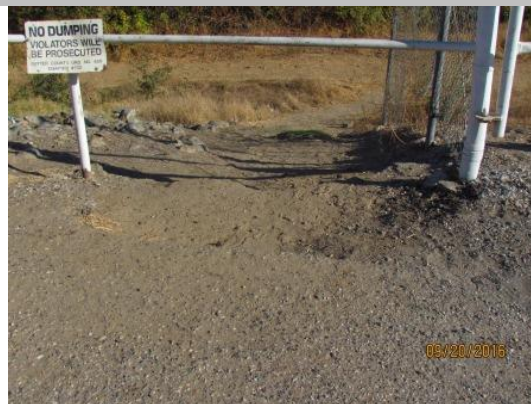
Photo 1 of 1 : SP\_2017\_RD1001\_37\_40\_20170316\_00029.jpg

LM Start	6.47	Rating **	M	Issue No.	40
LM End	6.47	Issue Type +	Ma	Location *	WS
Category	Earthen Levee			GPS Latitude/Longitude	
				Start	End
Item	Slope Stability			38.984020 °	38.984020 °
				-121.487404 °	-121.487404 °
DWR ID	DWR_RD1001_03_f_2016_40				
Comment Code					
S2 : Repair the levee slope damaged by foot traffic and prevent access where possible.					
Inspector Comment

View of slope instability on the waterside at gate caused by foot traffic. Fall 2016.

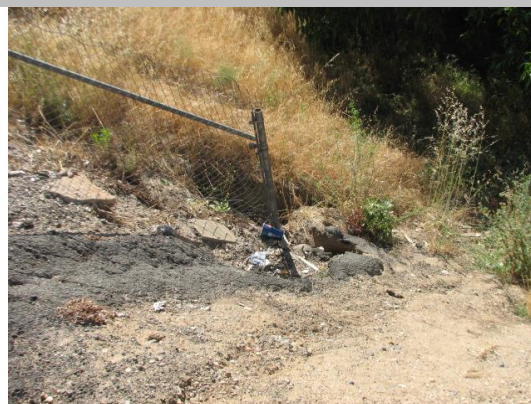
Photo 1 of 2 : SP\_2017\_RD1001\_37\_38\_20170316\_00026.jpg

Erosion caused by run off from the roadway. Spring 2013

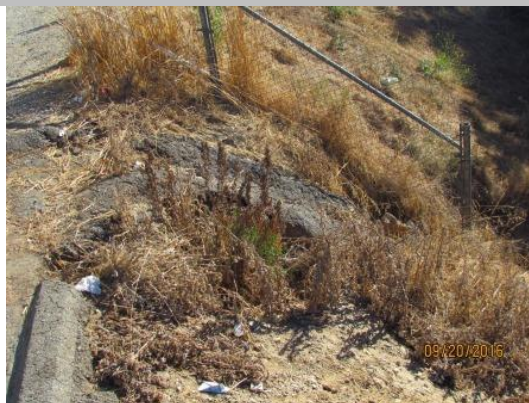
Photo 2 of 2 : SP\_2017\_RD1001\_37\_38\_20170316\_00027.jpg

Erosion caused by run off from the roadway still exist. Fall 2016.

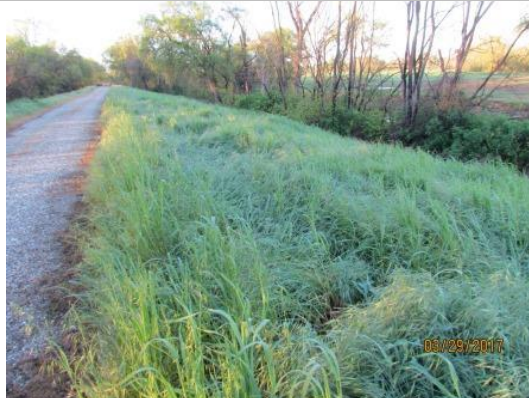
Photo 1 of 1 : SP\_2017\_RD1001\_38\_38\_20170403\_00067.jpg

View looking downstream of annual vegetation, Spring 2017.

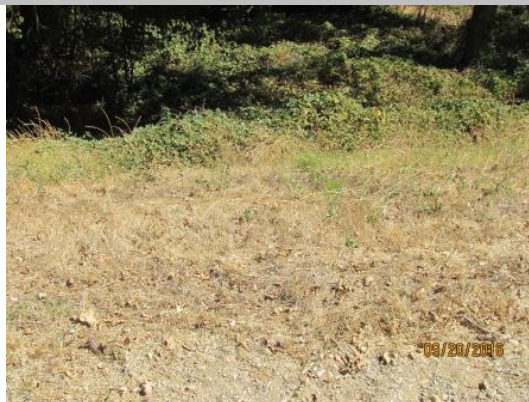
Photo 1 of 1 : SP\_2017\_RD1001\_38\_46\_20170316\_00027.jpg

View of blackberry bush starting to climb the landside levee slope. Fall 2016.

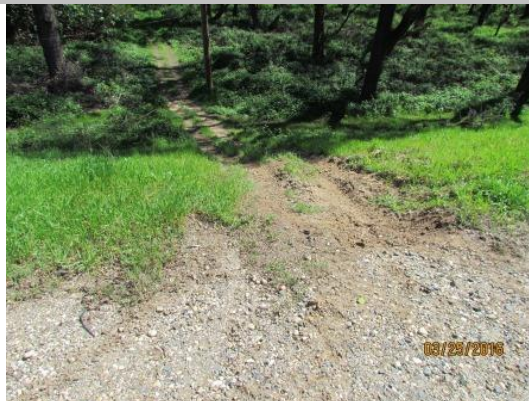
Photo 1 of 1 : SP\_2017\_RD1001\_38\_63\_20170316\_00036.jpg

Landside slope erosion caused by vehicles.

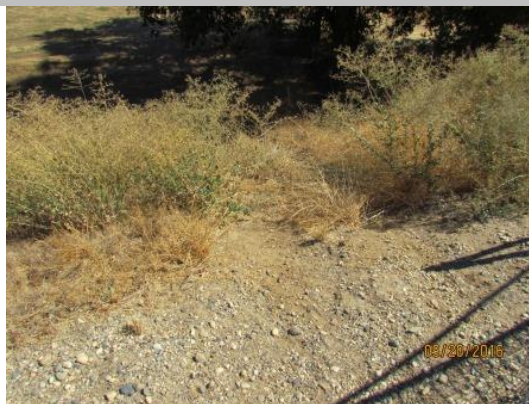
Photo 1 of 1 : SP\_2017\_RD1001\_38\_68\_20170316\_00040.jpg

View of ruts caused by vehicle on the landside levee slope. Fall 2016.

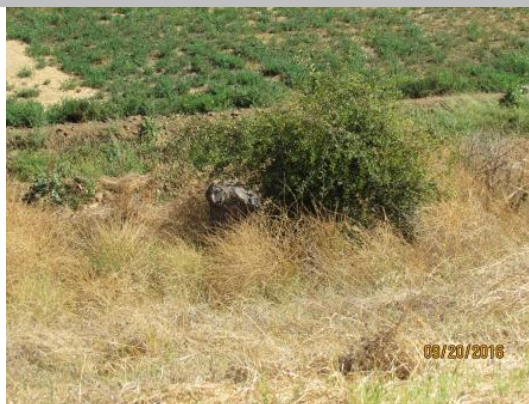
Photo 1 of 1 : SP\_2017\_RD1001\_38\_69\_20170316\_00041.jpg

View of stump at landside levee toe. Fall 2016.

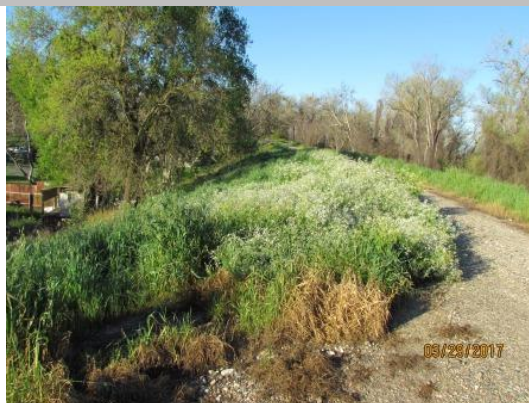
Photo 1 of 1 : SP\_2017\_RD1001\_38\_44\_20170403\_00073.jpg

View looking downstream of annual vegetation, Spring 2017.

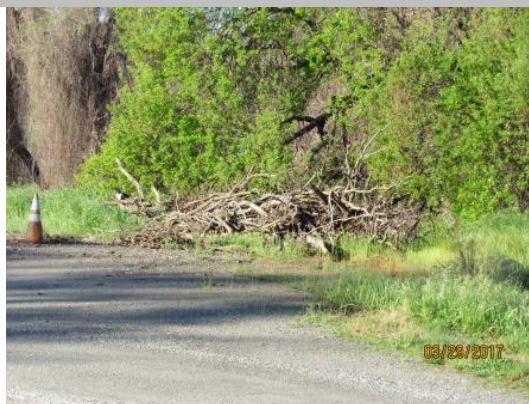
Photo 1 of 1 : SP\_2017\_RD1001\_38\_45\_20170403\_00072.jpg

View looking downstream of pruning's on hinge point, Spring 2017.

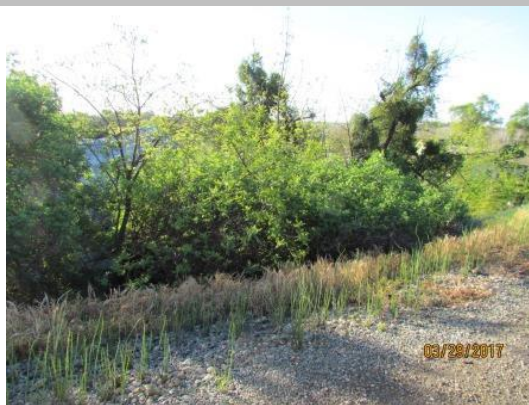
Photo 1 of 1 : SP\_2017\_RD1001\_38\_47\_20170403\_00074.jpg

View looking downstream where limbs need to be trimmed 5' for visibility, Spring 2017.

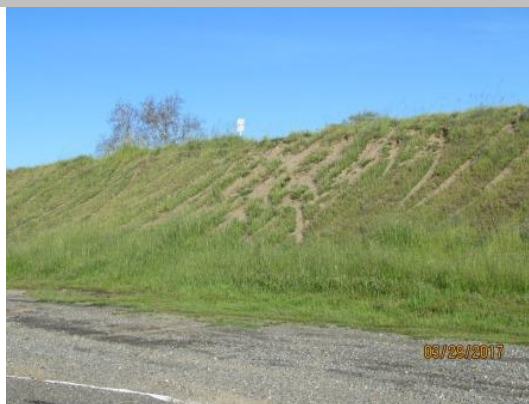
Photo 1 of 1 : SP\_2017\_RD1001\_38\_51\_20170403\_00078.jpg

View of continual vehicles driving up levee slope, should be monitored and maintained, Spring 2017.

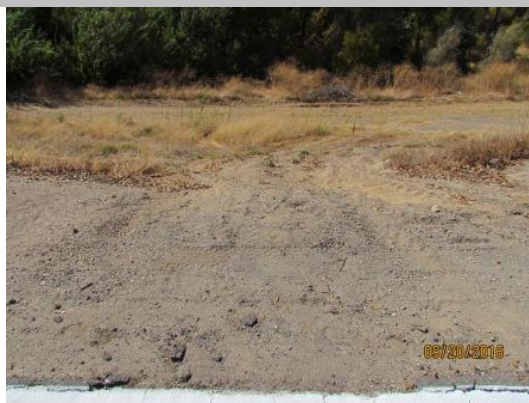
Photo 2 of 2 : SP\_2017\_RD1001\_38\_78\_20170316\_00043.jpg

Ruts still there on waterside slope due to vehicles. Fall 2016.

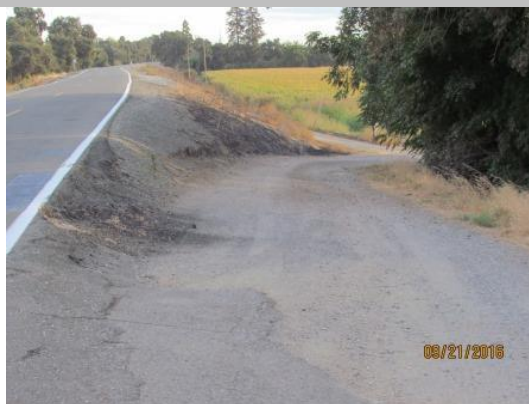
Photo 1 of 1 : SP\_2017\_RD1001\_38\_36\_20170316\_00023.jpg

View of vertical cut for ramp in the landside levee slope looking upstream. Fall 2016.

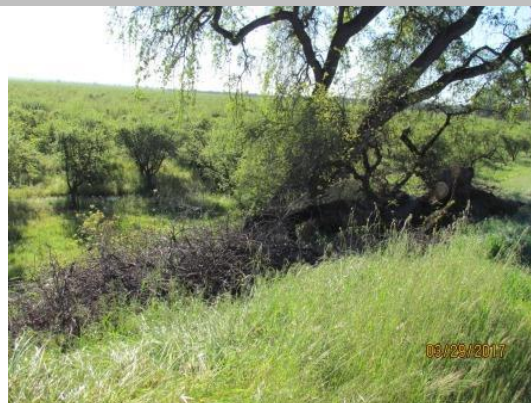
Photo 1 of 1 : SP\_2017\_RD1001\_38\_53\_20170403\_00080.jpg

View looking downstream at a downed tree and limbs, Spring 2017.

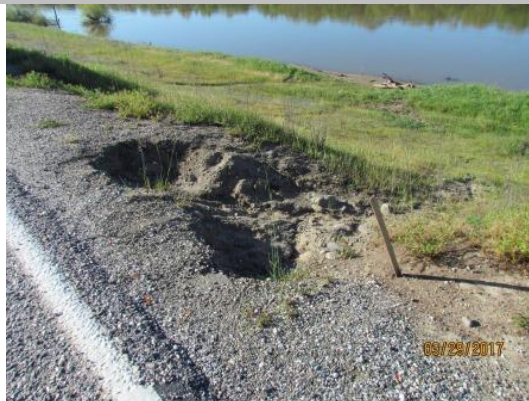
Photo 2 of 2 : SP\_2017\_RD1001\_38\_54\_20170403\_00079.jpg

View of vehicle ruts in levee shoulder that is getting worse due to erosion on the waterside looking downstream. Spring 2017.

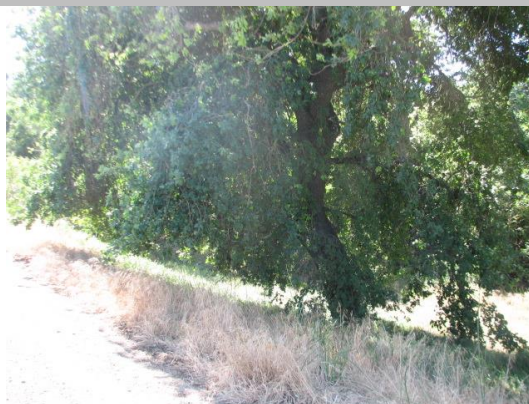
Photo 1 of 1 : SP\_2017\_RD1001\_38\_151\_20170316\_00046.jpg

Trees need to be trimmed up at least 5 feet. Spring 2013

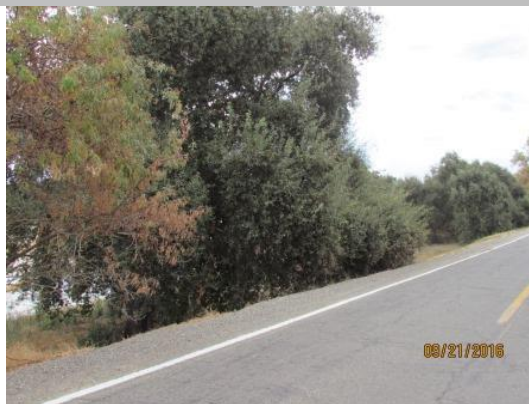
Photo 1 of 1 : SP\_2017\_RD1001\_38\_58\_20170316\_00032.jpg

View of landside tree that need the limbs trimmed up 5' above the slope for visibility and access. Fall 2016.

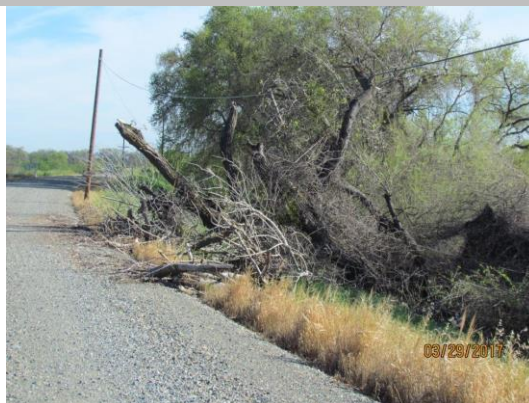
Photo 1 of 1 : SP\_2017\_RD1001\_39\_11\_20170403\_00018.jpg

View looking upstream of fallen tree in waterside slope, Spring 2017.

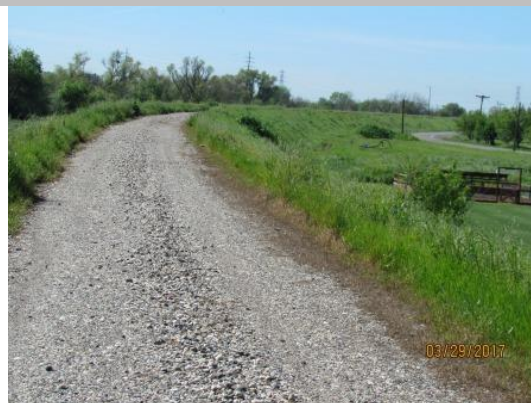
Photo 1 of 1 : SP\_2017\_RD1001\_40\_17\_20170403\_00039.jpg

View looking downstream of annual vegetation, Spring 2017.

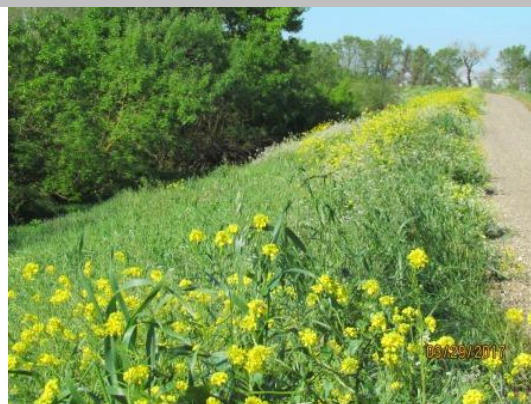
Photo 1 of 1 : SP\_2017\_RD1001\_40\_15\_20170403\_00037.jpg

View looking downstream of annual vegetation, Spring 2017.

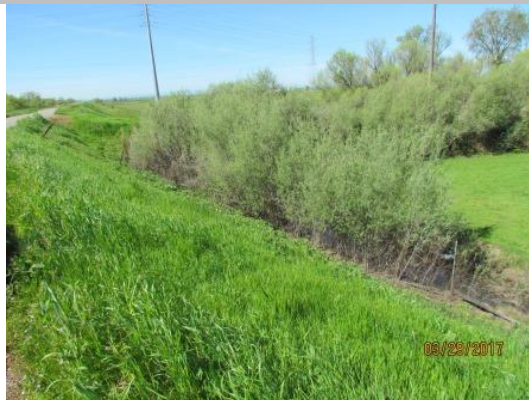
Photo 2 of 2 : SP\_2017\_RD1001\_40\_18\_20170403\_00040.jpg

View looking downstream of trees that need to be trimmed for visibility on the landside, Spring 2017.

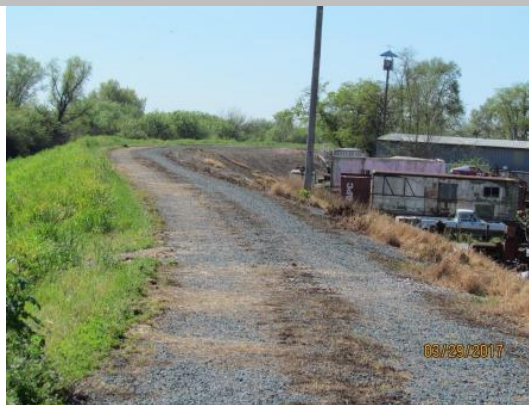
Photo 1 of 1 : SP\_2017\_RD1001\_40\_16\_20170403\_00038.jpg

View looking downstream of well maintained annual grasses, Spring 2017.

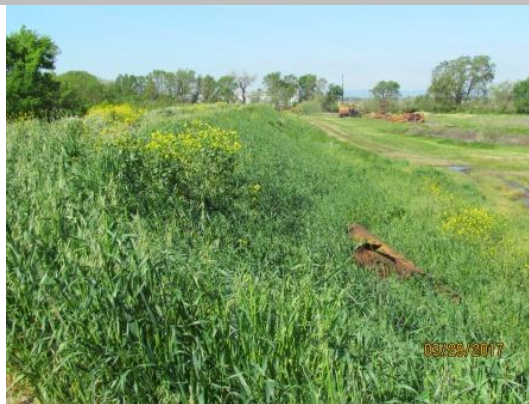
Photo 1 of 1 : SP\_2017\_RD1001\_40\_14\_20170403\_00036.jpg

View looking downstream of annual vegetation, Spring 2017.

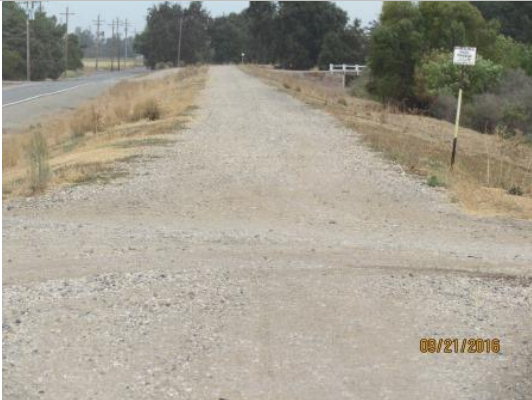
Photo 1 of 1 : SP\_2017\_RD1001\_40\_7\_20170316\_00002.jpg

View of crown where there is cross traffic looking upstream. Monitor this area and fix as needed.

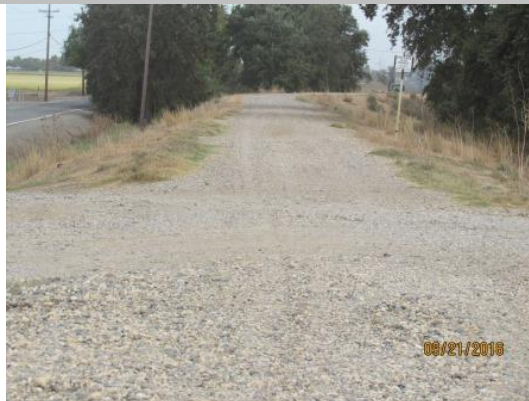
Photo 1 of 1 : SP\_2017\_RD1001\_40\_19\_20170316\_00005.jpg

View of crown where there is cross traffic looking upstream. Monitor this area and fix as needed.

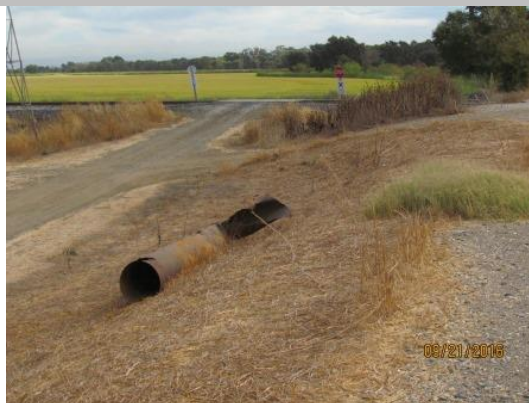
Photo 1 of 1 : SP\_2017\_RD1001\_40\_24\_20170316\_00009.jpg

View of an old piece of pipe lying on landside levee slope looking upstream. Fall 2016.
